# Drive Shaft Maintenance

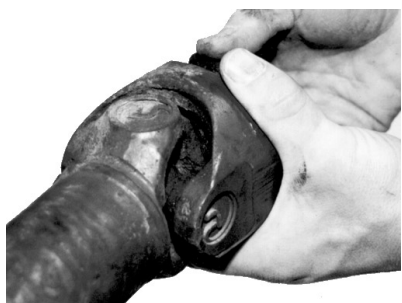
Inspection of the drive shaft will require the vehicle's transmission or transfer case to be placed into neutral. Be sure to set the parking brake. This is important because if there is any pressure on the drive shaft, you will not be able to detect the minimal clearances that will be the first indicators of an impending problem.

Try twisting each of the yokes that attach to the U joint in opposite directions and attempt to move them side to side, checking for movement independent of the U joints. If you have any detectable play, in any direction, you have too much.

Check the slip yoke & spline stub for excessive lateral play. A general recommendation is to allow no more than .007". If you have a dial indicator and a vice, this is an easy at-home check to perform. The wear pattern left by the dust cap of the slip yoke on the spline stub will usually be a good indicator of whether the shaft is running in the proper position and the extent of travel from compression to extension.

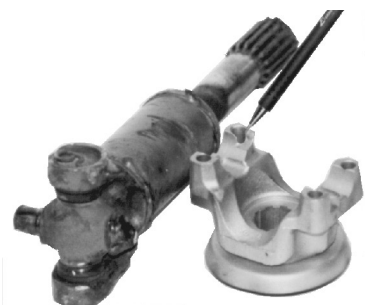
Now, you'll want to check the attaching yokes. Are they securely attached to the transfer case or differential? Often, the nut on either of these yokes will begin to back off. If this is the case, you will be able to see the yoke move independently of the output shaft or the pinion shaft. Be careful in your diagnosis here, though, as the symptoms may be a result of bearing wear. To arbitrarily tighten the nut will usually accelerate the failure of a worn bearing. If you discover the yoke is loose, it may be a good time to drain the gearbox for a thorough inspection of the oil to look for excessive metal contamination. In the event of a

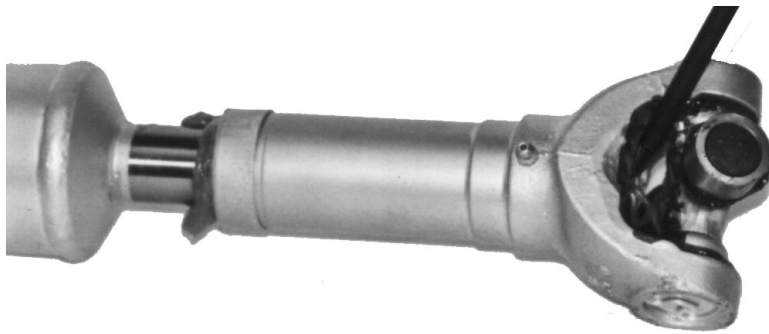
Proper greasing of the slip yoke will depend on the location of the grease fitting. On most older applications, the grease fitting is in the body of the slip yoke near the area that accepts the U joint. On many newer applications or reworked drive shafts, the grease fitting is in the dust cap at the end opposite the U joint (on either type of slip yoke you will find a relief hole in a plug that is in the end of the yoke under the U joint).

With the first type you need to put your finger over this hole and pump grease until you see clean grease coming out past the dust cap on the opposite end. Unless you do this, grease will simply fill the cavity in the slip yoke that is not filled with the spline stub and any excess will come out of the relief hole. With the second type, pump grease until you see clean grease coming out this relief hole. The object here is to make sure that clean grease will completely coat the wearing areas of the slip yoke and spline stub.

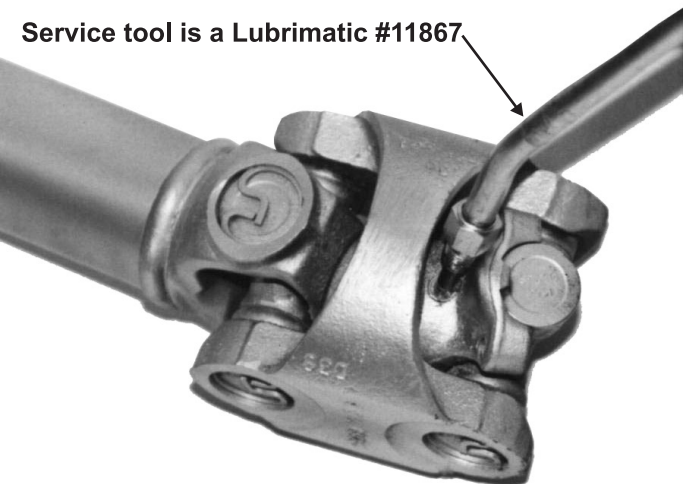
On a Spicer type of C.V. drive shaft, there will usually be a flush type grease fitting for lubrication of the center pivot point. The problem is, when the C.V. is opened where it would be accessible, this fitting is at the top of the shaft where you can't see it. If you turn the shaft until the fitting is at the bottom, the knuckle closes up and you can't get to it. The only viable solution I know of is to disconnect the drive shaft at the transfer case end, drop it down and grease it then. This should be done at least twice a year.
